Infrastructure Asset Management Plan

City of Spring Park

October 13, 2017

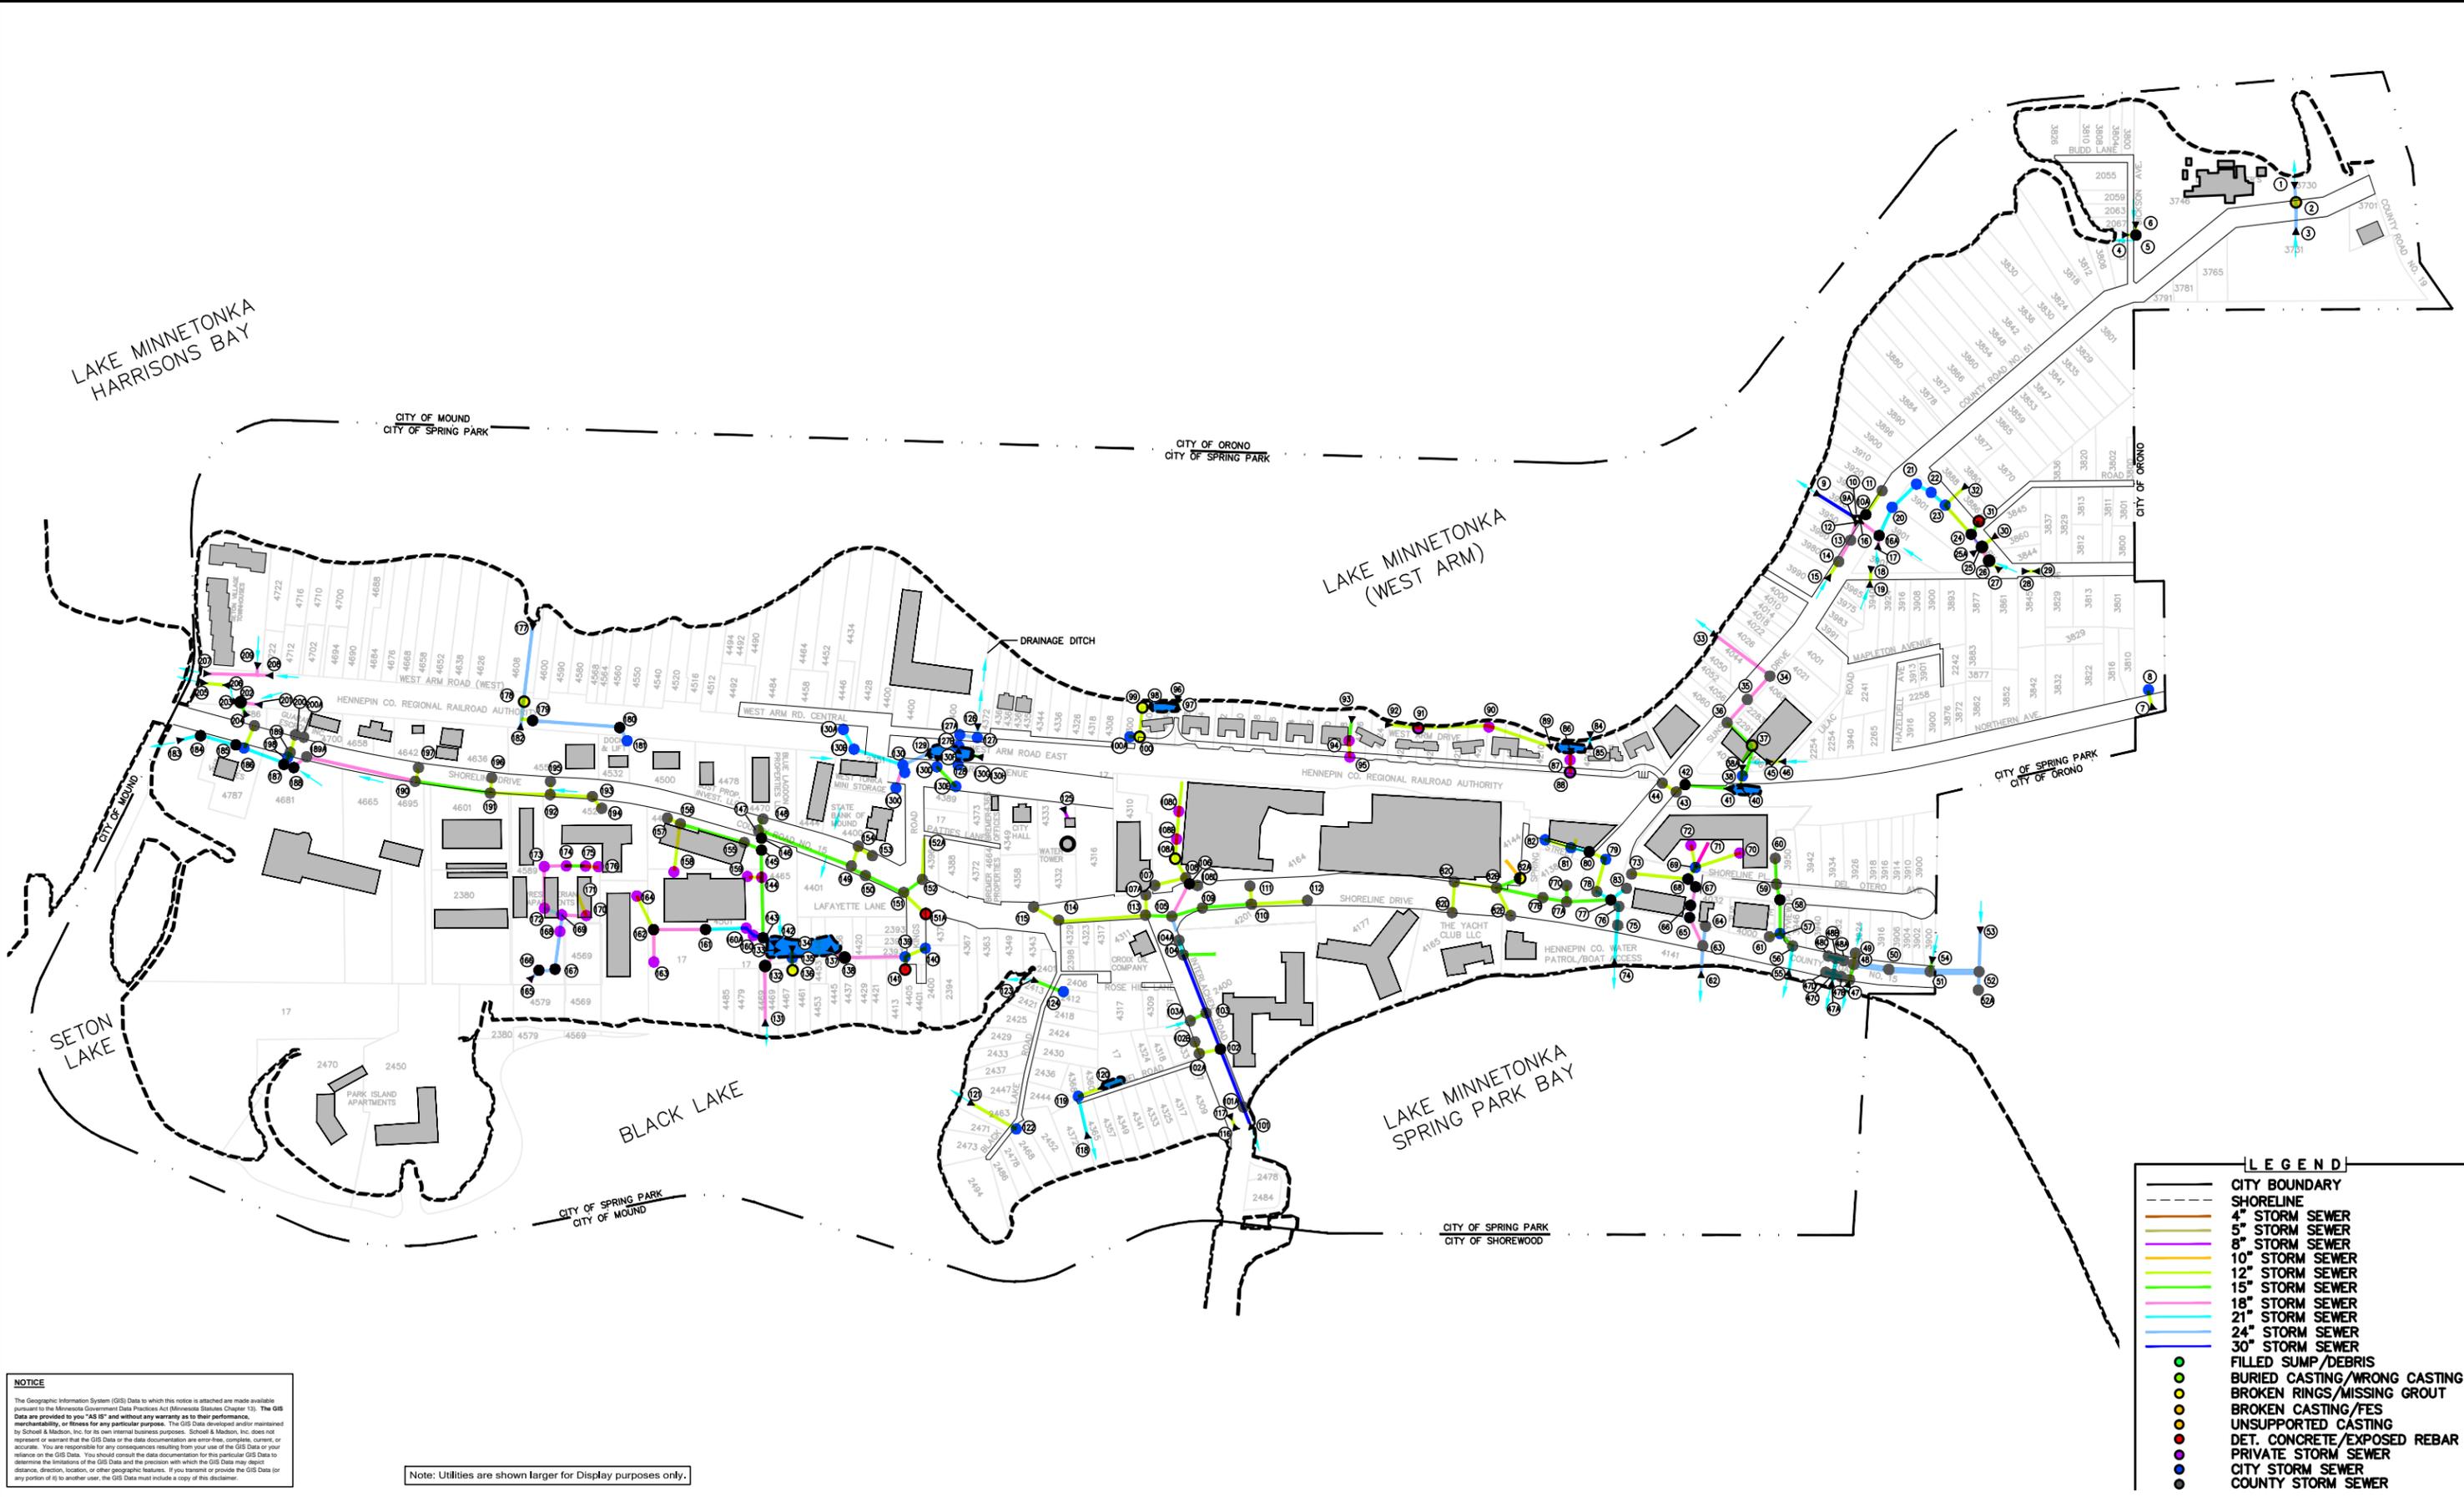
Project Name:	ASSET MANAGEMENT PLAN	Date:	10/13/17
Sheet Title:	STORM SEWER SYSTEM MAP	Sheet:	FIGURE-12

No CCTV was available to perform a storm pipe condition assessment. The pipe section between 2 structures was assumed to have a similar PACP rating to the adjacent structures. A summary of the storm sewer pipe inventory is shown in Appendix Table 5 and Figure 12.
