# Limited Environmental Site Assessment Spring Park Wells Site Assessment Project, Spring Park, Minnesota

RE: Limited Environmental Site Assessment – Spring Park Wells Site Assessment;  
AECOM Project 60305958

AECOM Technical Services, Inc. (AECOM) has completed a Limited Environmental Site Assessment for the Spring Park Wells. The assessment was based on a desk-top hydrogeologic review and a historical background evaluation for sites that have/had a potential to manage chlorinated volatile organic compounds (VOCs). Chlorinated VOCs are the contaminants of concern (COC) for this assessment since they have been detected in the City's water at low concentrations. A total of 19 Environmental Sites with a potential to impact the City of Spring Park municipal well field with COCs were identified.

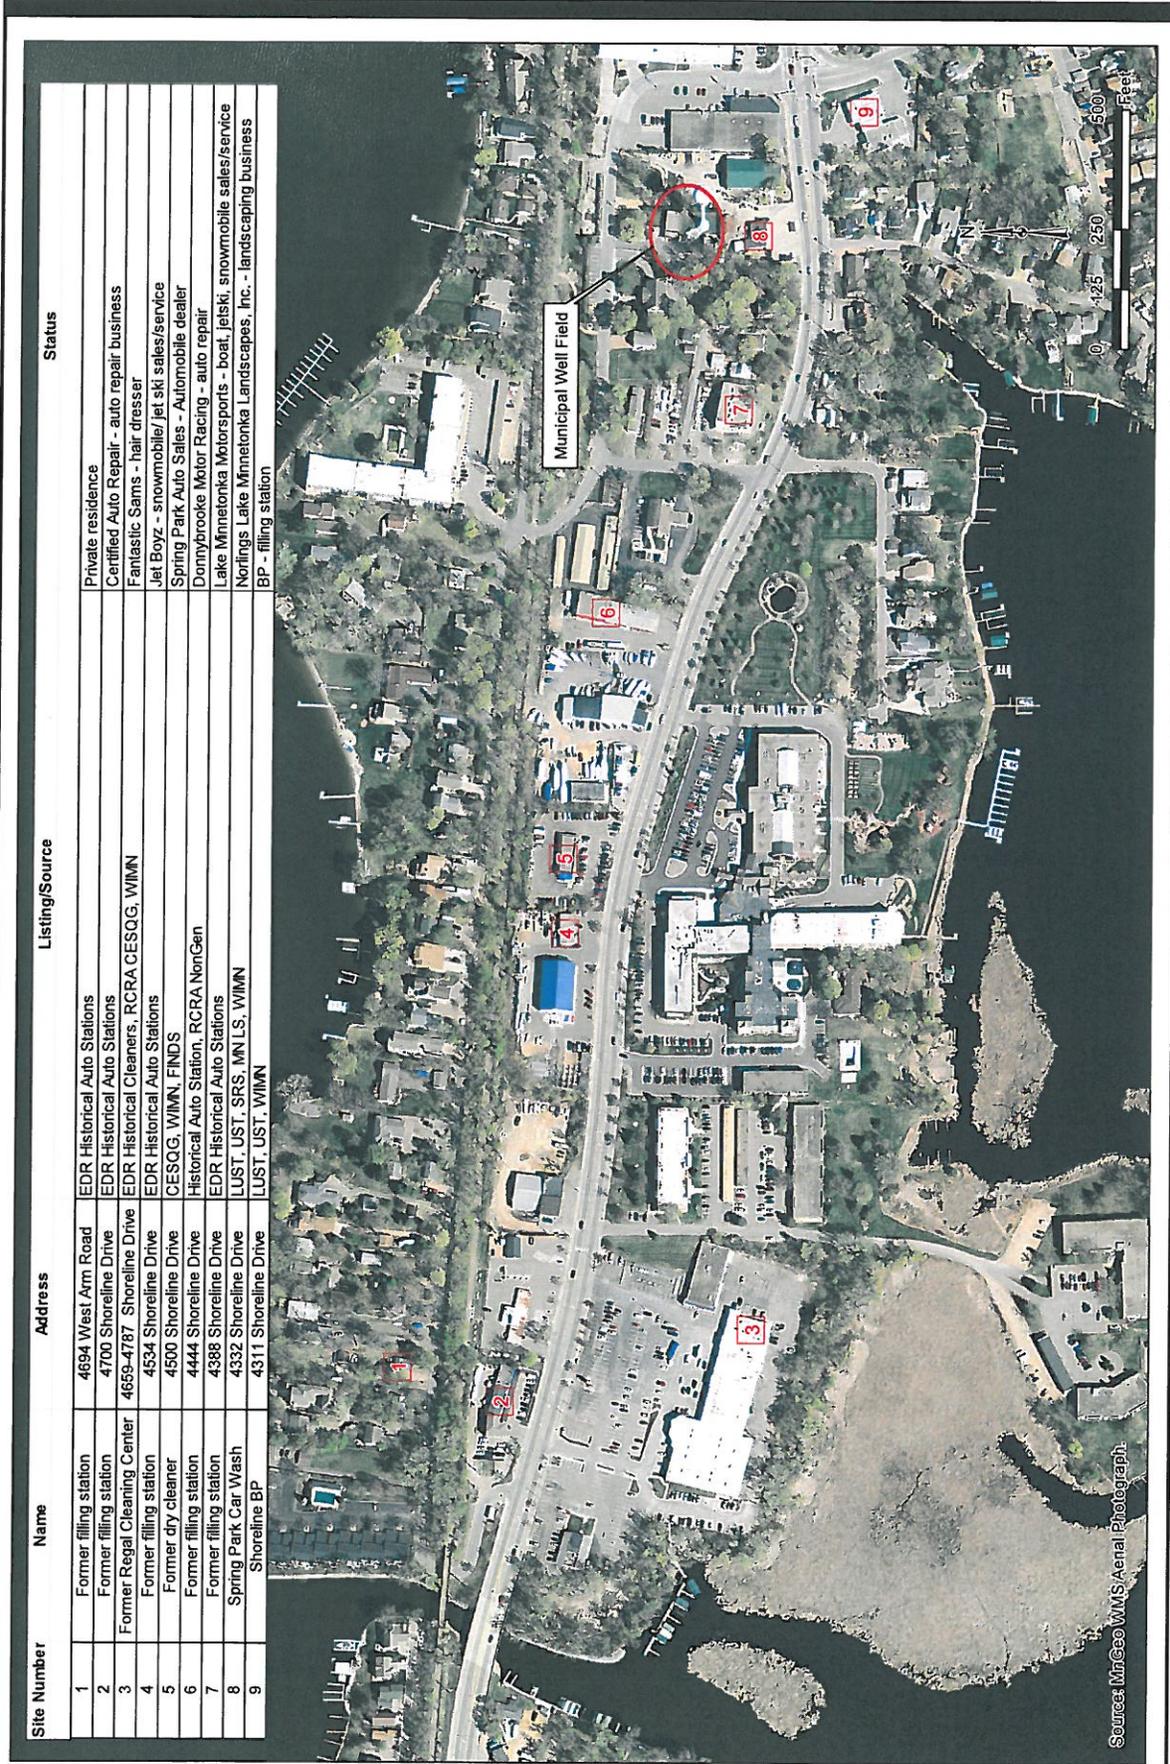
Figure 1

Site Number	Name	Address	Listing/Source	Status
1	Former filling station	4694 West Arm Road	EDR Historical Auto Stations	Private residence
2	Former filling station	4700 Shoreline Drive	EDR Historical Auto Stations	Certified Auto Repair - auto repair business
3	Former Regal Cleaning Center	4659-4787 Shoreline Drive	EDR Historical Cleaners, RCRA, CESQG, WIMN	Fantastic Sams - hair dresser
4	Former filling station	4534 Shoreline Drive	EDR Historical Auto Stations	Jet Boyz - snowmobile/jet ski sales/service
5	Former dry cleaner	4500 Shoreline Drive	CESQG, WIMN, FINDS	Spring Park Auto Sales - Automobile dealer
6	Former filling station	4444 Shoreline Drive	Historical Auto Station, RCRA NonGen	Donnybrooke Motor Racing - auto repair
7	Former filling station	4388 Shoreline Drive	EDR Historical Auto Stations	Lake Minnetonka Motorsports - boat, jetski, snowmobile sales/service
8	Spring Park Car Wash	4332 Shoreline Drive	LUST, UST, SRS, MN LS, WIMN	Norflings Lake Minnetonka Landscapes, Inc. - landscaping business

9	Shoreline BP	4311 Shoreline Drive	LUST, UST, WIMN	BP - filling station

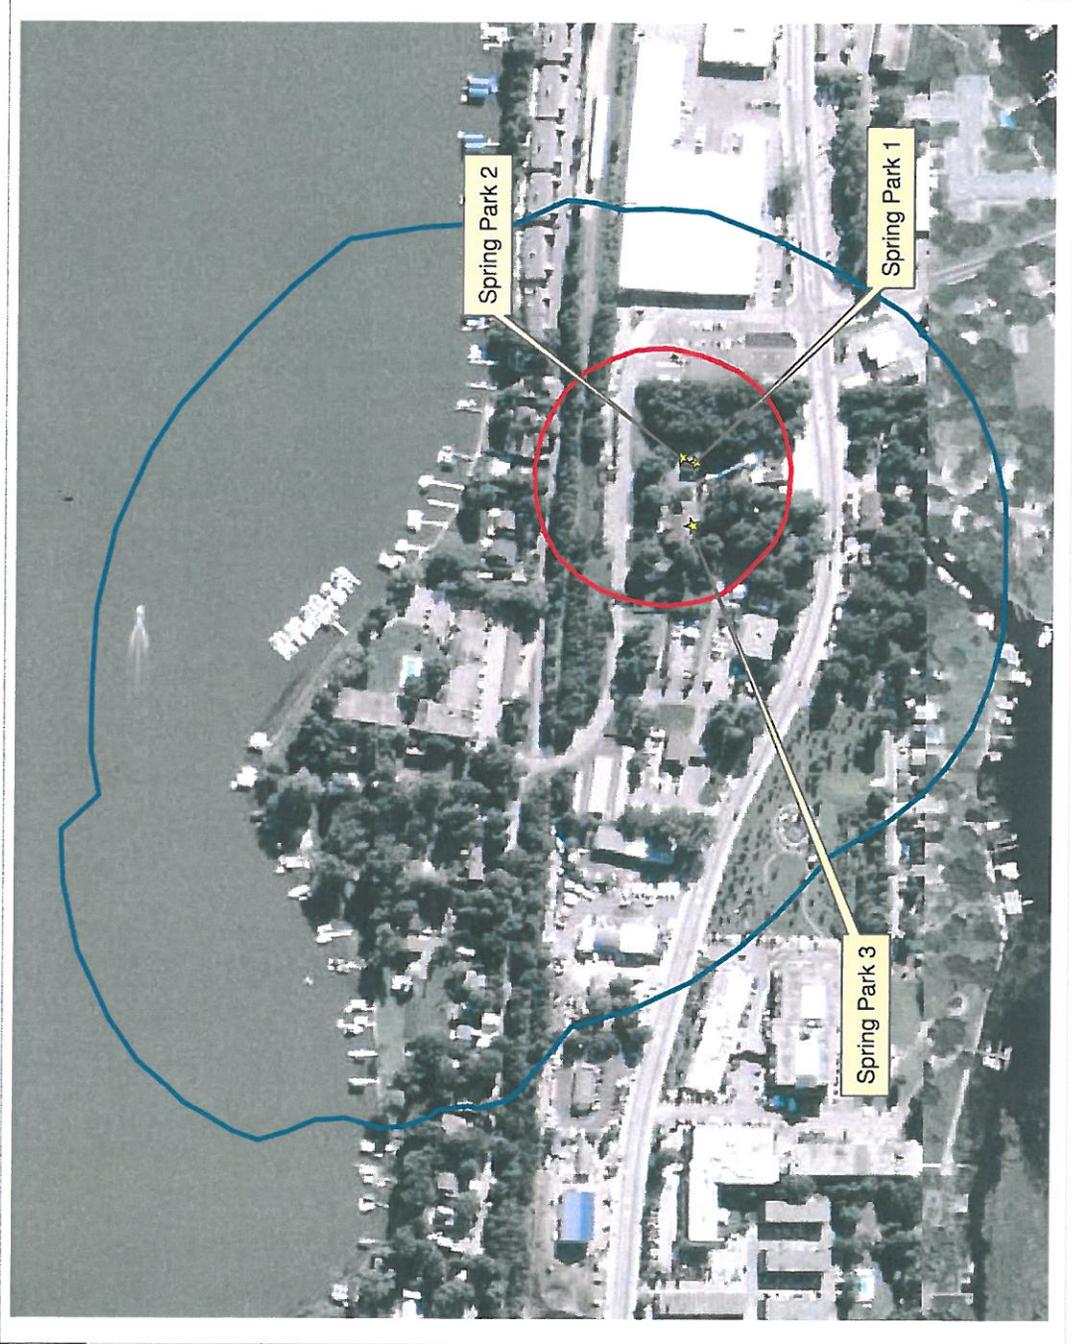
Emergency Response Area  
Composite WHPA

Source: MDH 2010

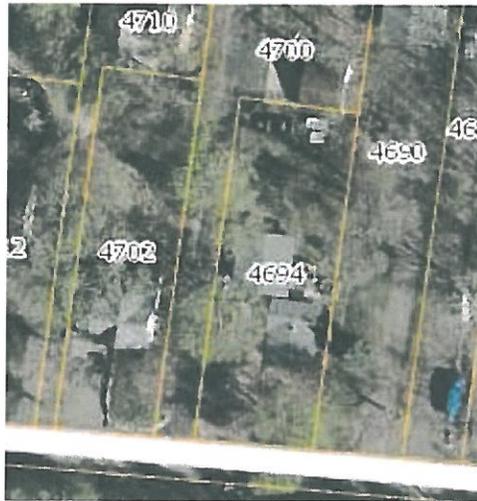
Project No. 60305958

**Current Use** – Private residence

**Environmental Concerns** – Former gas station – petroleum products in former underground storage tanks (USTs); possible solvent use for automobile repair.

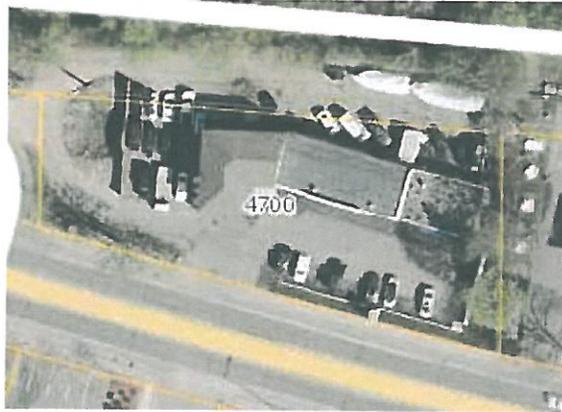
Project No. 60305958

**Current Use** – Automobile repair facility (Certified Auto Repair)

**Environmental Concerns** – Former gas station – petroleum products in former underground storage tanks (USTs); possible solvent use for automobile repair.

**Aerial Photograph Interpretations** – The property was undeveloped on the 1937 through 1978 aerial photographs. A building approximately one-half the size that exists today was on the east central part of the property on the 1984 aerial photograph. The building was expanded to the west on the 1987 aerial photograph. Another expansion to the west was observed on the 2008 aerial photograph. The 2010 aerial photograph showed the building in the same apparent configuration as exists today. Multiple automobiles were observed parked on the property on several of the aerial photographs.

**Potential for Environmental Impact** – Medium potential to impact the municipal well field is anticipated. The former filling station/auto repair facility is located approximately 2500 feet west of the well field.

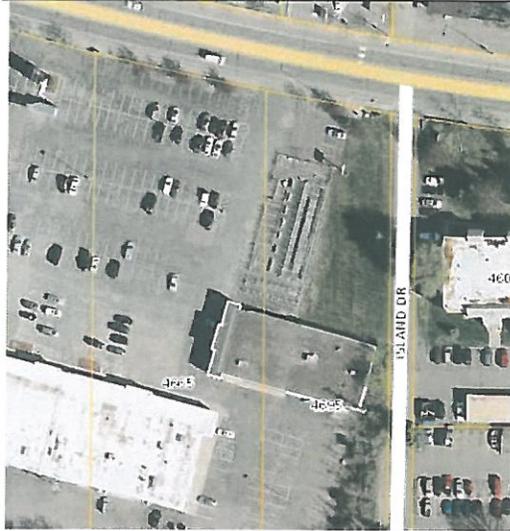
Site Address: 4659-4787 Shoreline Drive

**Current Use** – Hair dressing salon (Fantastic Sams)

**Environmental Concerns** – Former dry cleaner in east end of strip mall building: known perchloroethylene release site

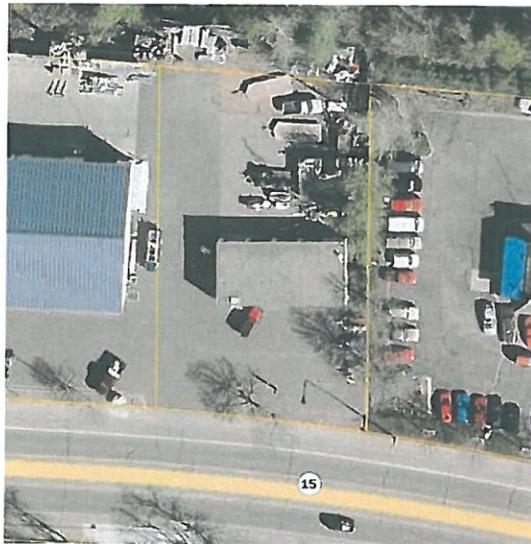
Project No. 60305958

**Current Use** – Motor sports sales/repair facility (Jet Boyz)

**Environmental Concerns** – Former gas station – petroleum products in former underground storage tanks (USTs); possible solvent use for vehicle repair.

**Potential for Environmental Impact** – Medium potential to impact the municipal well field is anticipated. The former filling station/auto repair facility is located approximately 1500 feet west of the well field.

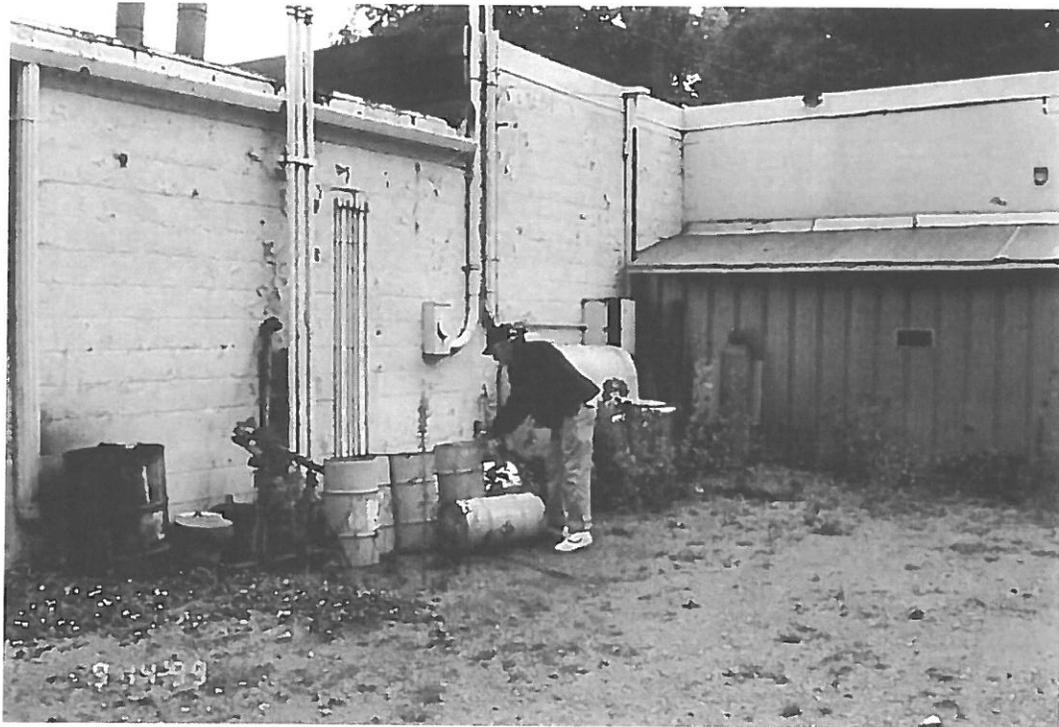
**Review of City of Spring Park Files –** A photograph taken in 1999 (see below) of outside storage of barrels indicates potential for release of hazardous materials to the environment. No soil borings conducted for the Phase II ESA (see above) were performed in the area of the barrels. Whether a

release of solvents occurred from the barrels or possible previous spills adjacent to the building in the area of the barrels is unknown.

**Potential for Environmental Impact** – High potential to impact the municipal well field is anticipated. Although no extensive contamination by VOCs was identified by the Phase II ESA conducted on the site, potential exists that solvents could have been released in areas where soil borings were not performed. The property is located adjacent to the south side of the municipal well field.

- Conduct a Phase II Environmental Site Assessment at the Former Factory Site/JR Clark Co (Site10). This site is of special concern since this assessment identified the possible presence of septic tanks in use during a period in which COCs could have been used at the site. The timeframe pre-dates RCRA regulations mandating appropriate storage and disposal of hazardous wastes. A historical photograph from 1969 shows numerous barrels stored outdoors without secondary containment.

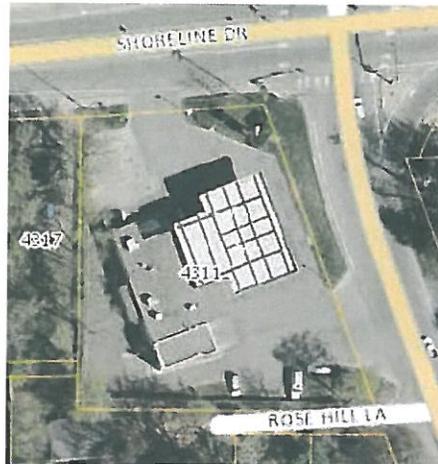
Site Address: 4311 Shoreline Drive

**Current Use** – Filling station (Shoreline BP)

**Environmental Concerns** –Gas station – petroleum products in former underground storage tanks (USTs); possible former use of solvents for automobile repair

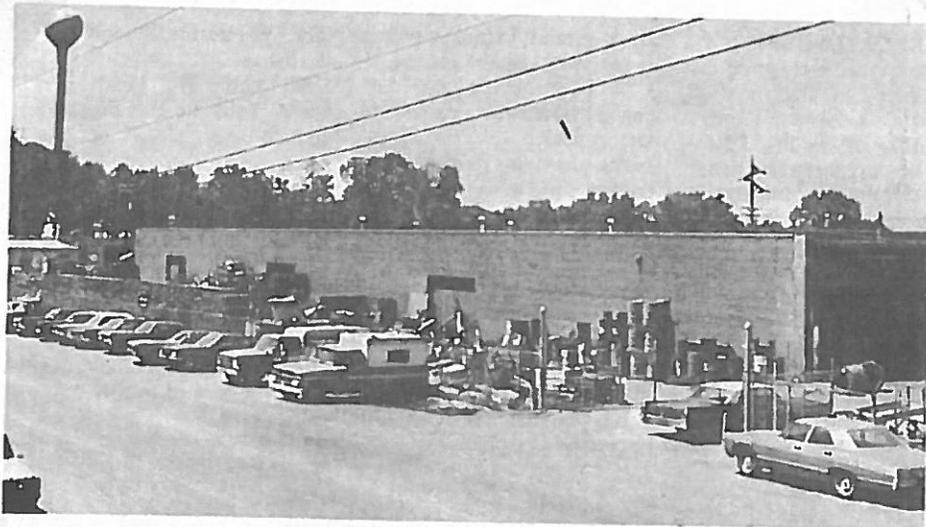
5/14/69

A letter from the City of Spring Park to the J.R. Clark company president noted that septic tanks located in a park south of the facility across County Highway 15 (Shoreline Drive) had not yet been decommissioned. Potential exists that solvents could have been released to the subsurface environment through the septic tank infiltration system prior to the existence of public sewer. The public sanitary sewer collection system in Spring Park was installed in 1963.

**Potential for Environmental Impact** – High potential to impact the municipal well field is anticipated. Paint booths and a machine shop in the former J.R. Clark factory likely used solvents. Solvents could have been released to the environment through spills in the outside barrel storage area, discharge through the septic system, leaking sewer pipes below the facility or drainage pits in the facility, or other means. The site is located approximately 1,000 feet east of the municipal well field.

FROM APARTMENT WINDOWS above or car windows approaching from either direction, the J. R. Clark Co. roadside storage area in Spring Park is less than beautiful. Removal of the junk, or orderly storage, at least, would undoubtedly find favor with the company's friends and neighbors.

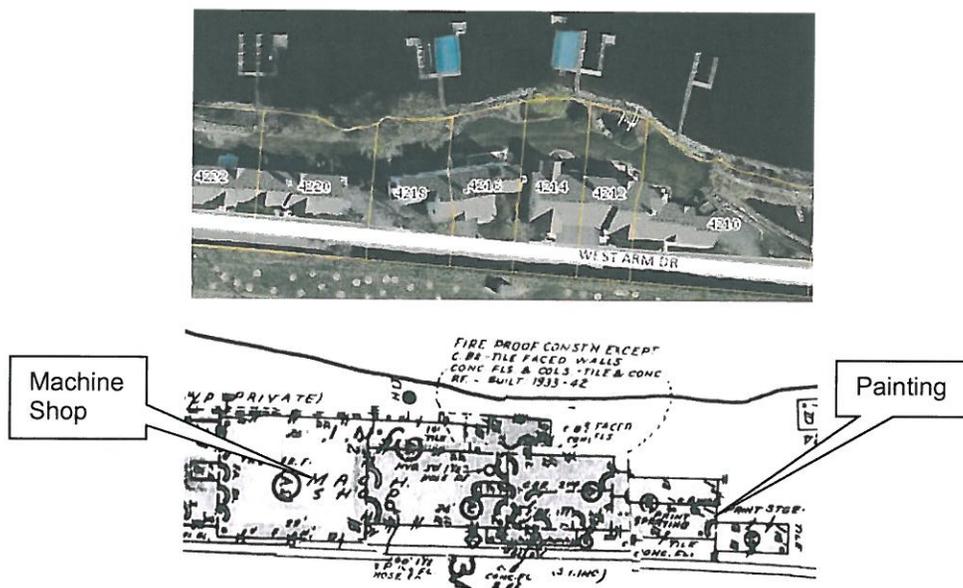
Site Address: 4080 and 4125 – 4129 Sunset Drive (4218 – 4222 West Arm Drive)

### Current Use – Townhomes

**Environmental Concerns** –Former manufacturing facility site with machine shop and painting facility. Release of chlorinated solvents documented with soil vapor impacts from impacted groundwater and soil to existing townhomes.

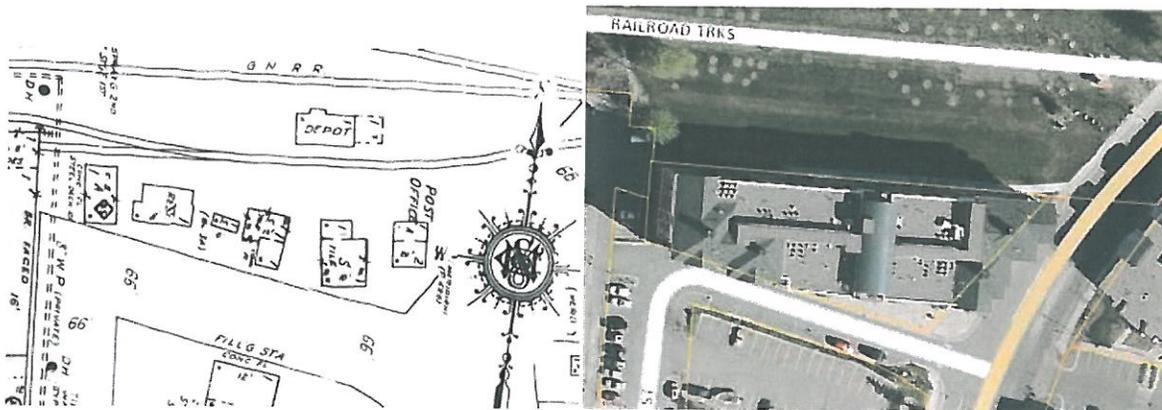
Site Address: 4102 to 4136 Spring Street

**Current Use** – Condominiums

**Environmental Concerns** – Former gas station – petroleum products in former underground storage tanks (USTs); automobile repair

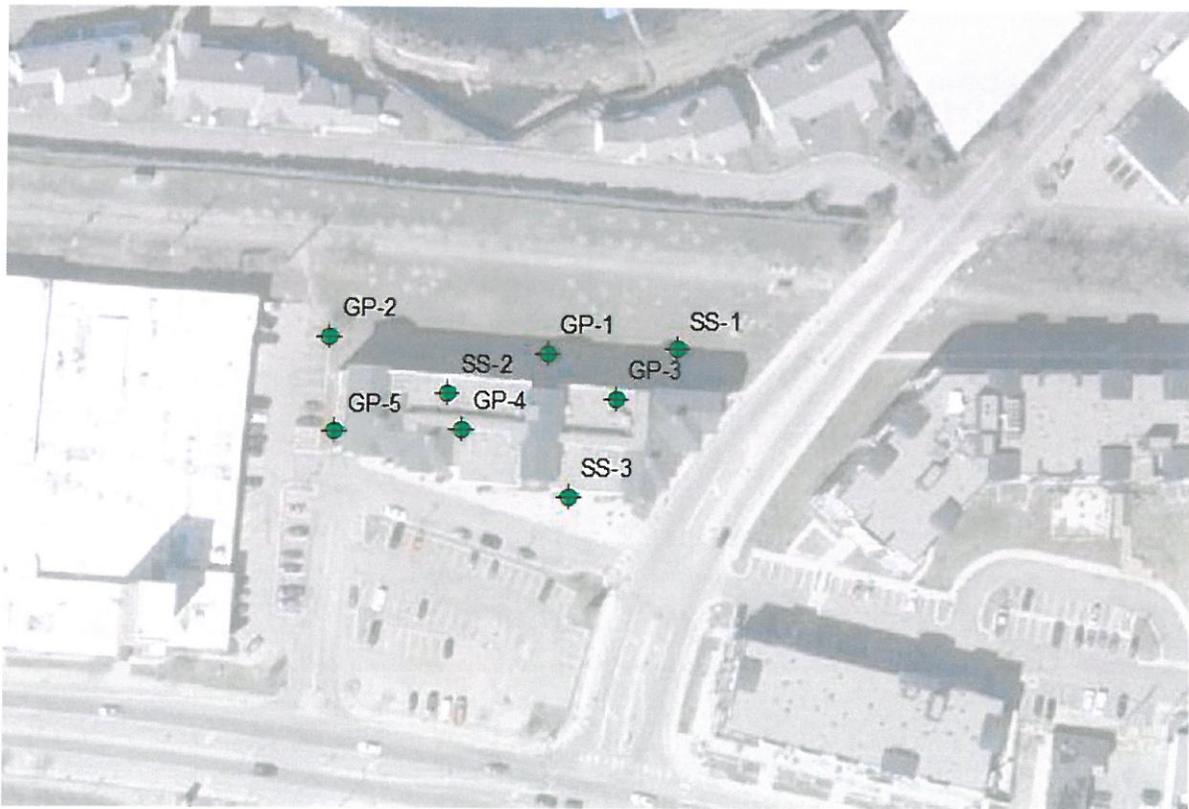
**Summary of MPCA File Information** – A Phase I Environmental Site Assessments (ESA) identified potential environmental conditions including former property use for a filling station, fill pipes for USTs and a nearby Voluntary Investigation and Cleanup (VIC) site with groundwater impacted by chlorinated volatile organic compounds (VOCs) to the north/northeast of the property. A Phase II ESA conducted at the property identified limited petroleum impacts to soil and low concentrations of chlorinated solvents in groundwater from an apparent off-site source. The possible source was not identified. Site redevelopment was conducted under a Development Response Action Plan (DRAP). The DRAP Implementation Report indicated approximately 5,000 cubic yards of petroleum impacted soil was excavated and disposed of and a vapor barrier was installed below the constructed building. A No Association Letter from the MPCA VIC program was requested to address the identified groundwater impacts. A table summary and aerial photograph of the groundwater findings are Provided below:

VOC Compounds in Groundwater (µg/L)								
Compound	GP-1		GP-2		GP-3		GP-4	GP-5
	26-30 feet	46-50 feet	25-29 feet	45-49 feet	25-29 feet	45-49 feet	27-31 feet	21-25 feet
TCE	ND	36	31	340	ND	ND	7	ND
Cis-1,2-DCE	41	ND						
All Other VOCs	ND

**Potential for Environmental Impact** – Known release of TCE; however, the low concentrations of chlorinated solvents in groundwater at the site area credited to an off-site source.

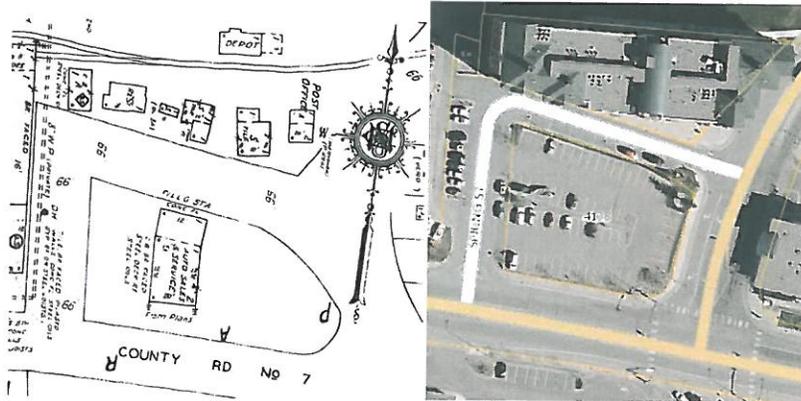
Site Address: 4138 Spring Street

### Current Use – Parking lot

**Environmental Concerns** – Former gas station and automobile repair – petroleum products in former underground storage tanks (USTs) and possible solvent use for automobile repairs.

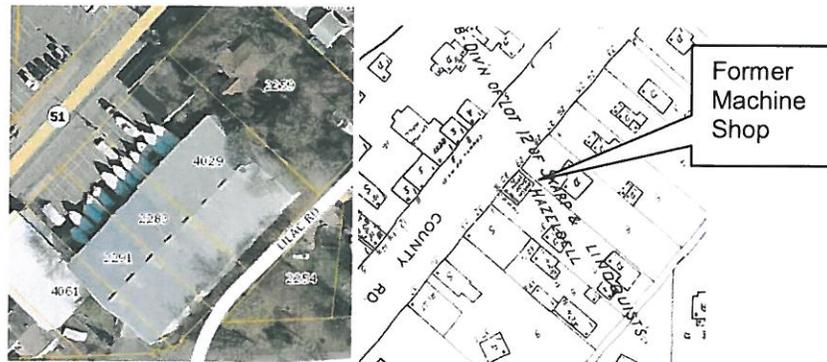
Site Address: 4029 Sunset Drive

**Current Use** – Rockvam Boat Yards, Inc., pleasure boat sales, repair and storage

**Environmental Concerns** – Former machine shop: possible use of solvents

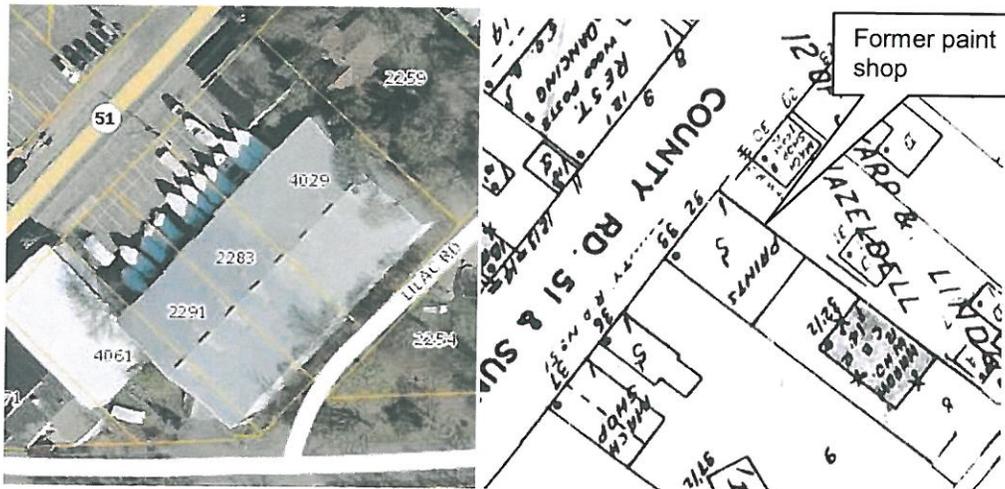
Site Address: 2283 Lilac Road

**Current Use** – Rockvam Boat Yards, Inc., pleasure boat sales, repair and storage

**Environmental Concerns** – Former paint shop: possible use of solvents

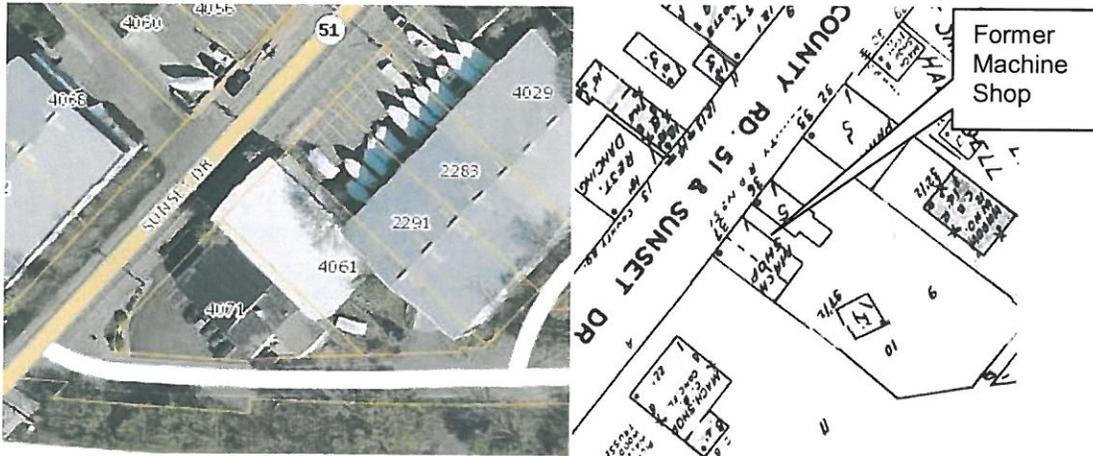
Site Address: 4061 Sunset Drive

**Current Use** – Rockvam Boat Yards, Inc., pleasure boat sales, repair and storage

**Environmental Concerns** – Former machine shop: possible use of solvents

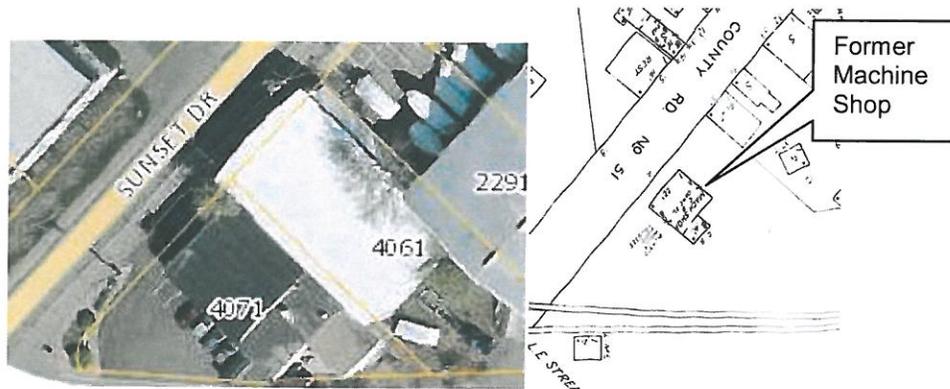
Site Address: 4071 Sunset Drive

**Current Use** – Lake Minnetonka Communications, public access television

**Environmental Concerns** – Former machine shop: possible use of solvents

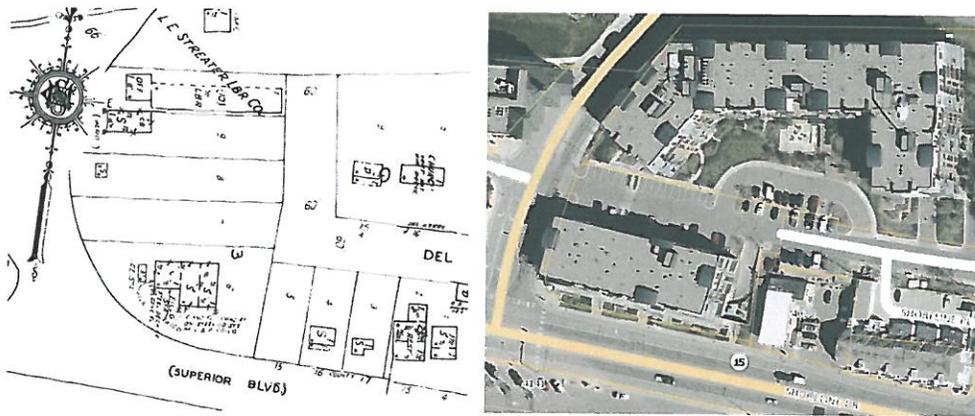
Site Address: 4100 Shoreline Drive

**Current Use** – Condominiums and offices (The Mist)

**Environmental Concerns** – Former gas station – petroleum products in former underground storage tanks (USTs) and possible solvent use for automobile repairs.
